Ultrasonic Techniques for the Assessment of Aging and Damage Accumulation in PMMA Cement and Cement/Metal Interfaces

N Saffari¹, M Browne² and Guillermo Rus³

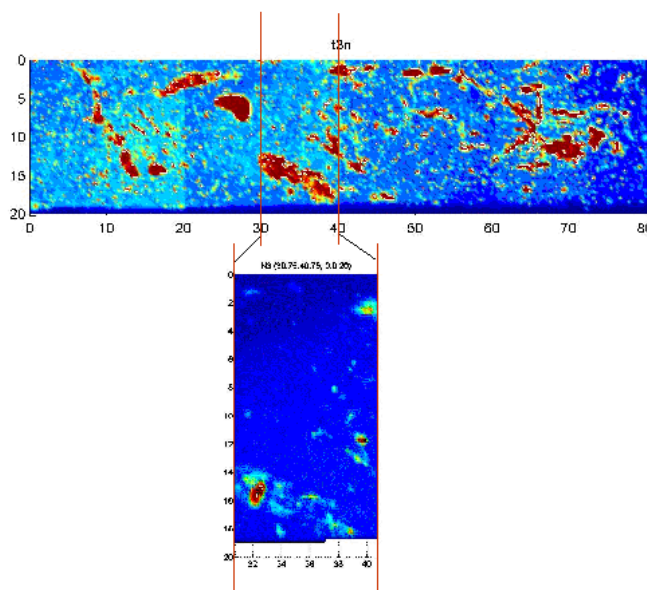
Figure 1. Accumulation of damage in bone cement - before (below) and after (above)
