Durability of masonry systems: A laboratory study

G. Cultrone ^{*}, E. Sebastián, M. Ortega Huertas

Department of Mineralogy and Petrology, University of Granada, Avda. Fuentenueva s/n, 18002 Granada, Spain

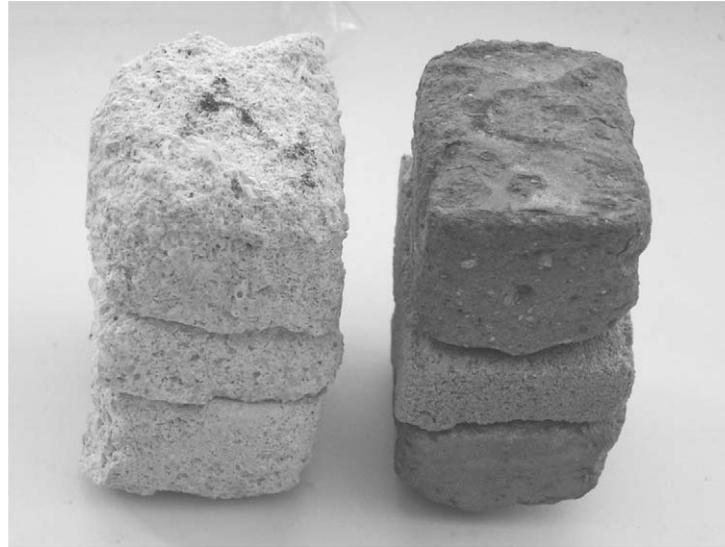
Fig. 7. Appearance of 2 samples of deteriorated masonry systems (C + L on the left and B + LP on the right) after salt crystallization test.

The salt-crystallization test had a considerable effect on sample stability. Most samples suffered a marked weight loss due to granular disintegration and cracking, especially along the mortar-stone/brick contact zone (Fig. 7).

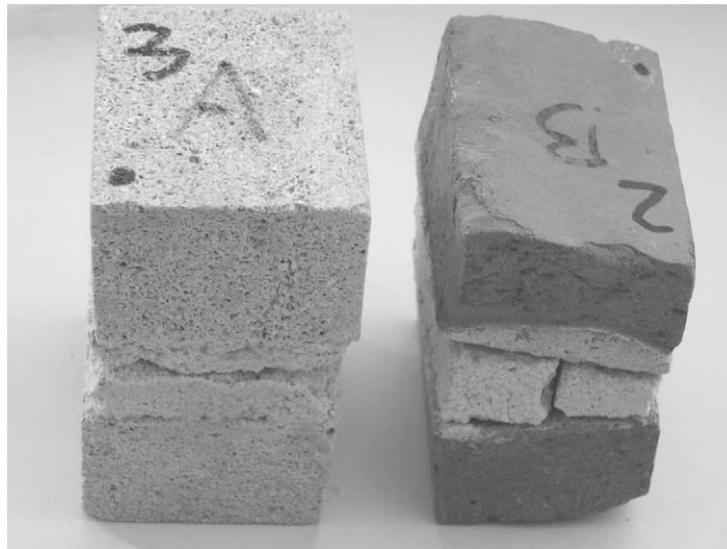
Fig. 9. Appearance of 2 samples of deteriorated masonry systems (C + L on the left and B + LA on the right) after freeze–thaw test.

The response of the samples to the freeze–thaw test was different from their response to sodium-sulphate attack (Fig. 9). Firstly, brick and calcarenite did not show any damage visible to the eye after 30 test cycles (Fig. 10(a)) whereas the LA and LP mortars suffered an appreciable
