Weathering of serpentinite stone due to in situ generation of calcium and magnesium sulfates

This paper presents a thorough study of the main features and the decay causes and mechanisms of serpentinites both freshly quarried and after centuries exposure at the main façade of the sixteenth century Royal Chancery (Granada, Spain). In particular, the process of in situ formation of calcium and magnesium sulfates has been studied. Several decay factors are identified, all of them acting synergistically in the deterioration of slabs made of serpentinite. Among them, chemical weathering of sulfides such as pyrite present in the original serpentinite induces the formation of sulfate salts such as gypsum or epsomite, salts which are considered the main cause of decay. In addition, unsuitable restoration treatments involving the use of Portland cement to fill up cracks and surface lacunae, the polluted environment of the surrounding area, and the location of the slabs close to the ground, favoring capillary rise of water, all contributed to their deterioration. This work helps to gain knowledge on the deterioration process of ornaments made of serpentinite, allowing us to propose the most

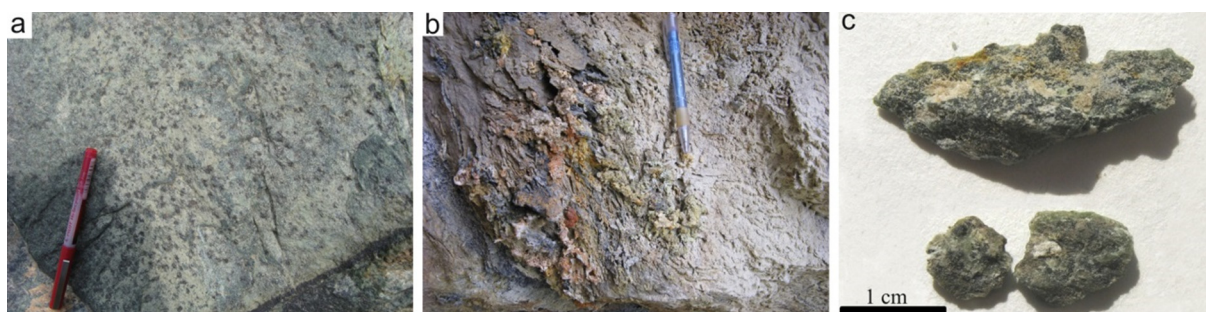
Fig. 3. a) Field aspect of serpentinites where the quarry samples were taken; b) disaggregated alteration material close to a fractured area in the face of the serpentinite quarry; c) serpentinite samples from the Royal Chancery. The samples are scales that fell off just by gently touching the surface due to the high level of decay.

To characterize the main features of the serpentinites of the “Barranco de San Juan” quarry, several samples with similar appearance (total weight about 40 kg) were taken from the original quarry face (Fig. 3a). These samples were cut into parallelepipeds with different sizes to get enough material for testing (Samples BSJ 1 to BSJ 5). In addition, six samples of fine-grained, apparently altered material filling fractures or precipitated on the surface, with different colors (red, yellow, brown, and white) were also collected (Fig. 3b). The different varieties observed were separated by handpicking based on color (Samples BSJ 10 to BSJ 15).

Regarding the Royal Chancery building, four samples (CHAN 1 to 4) (Fig. 3c) of different sizes (maximum 3 cm) of disaggregated material from the outer slabs placed at the bottom under the columns of the main façade were collected. No extra damage was caused to the building during this sampling.
