# Pigment and Plasterwork Analyses of Nasrid Polychromed Lacework Stucco in the Alhambra (Granada, Spain)

Carolina Cardell-Fernández and Carmen Navarrete-Aguilera

*This paper deals with the description of the stucco (decorative plasterwork) and pigments used in the Alhambra (Granada, southern Spain). The nature, structure and deterioration of these materials are described in detail, as well as the painting and stucco techniques employed. A cast plaster technique is found throughout the Lions Palace (late Nasrid period, second half of the fourteenth century), whereas plaster carved in situ is only found in certain areas of the Partal Palace, one of the oldest constructions still extant in the Alhambra (1302–1309). Two original Nasrid palettes were also identified: an earlier, simpler palette of blue, red and black, and a later, more varied palette of red, blue, green, black and gold. In both cases white was the background colour. The gold decoration technique is described, as are the Christian interventions. Rich pigments were used throughout the history of the Alhambra (e.g. gold, lapis lazuli, azurite, malachite, cinnabar and red lead). Some pigments, red lead and malachite in p

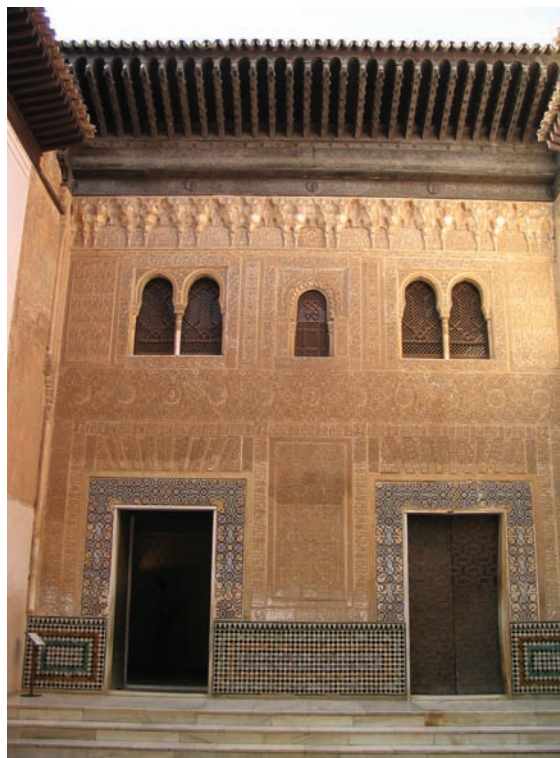
**Figure 2** Façade of the Comares Palace showing the basic decoration technique used in the Alhambra: dado tiling at the bottom and stucco decoration above, becoming more intricate with height in the muqarnas. Woodwork is restricted to eaves, doors and ceilings. The eaves of the Comares Façade are considered the apotheosis of Hispano-Muslim carpentry.

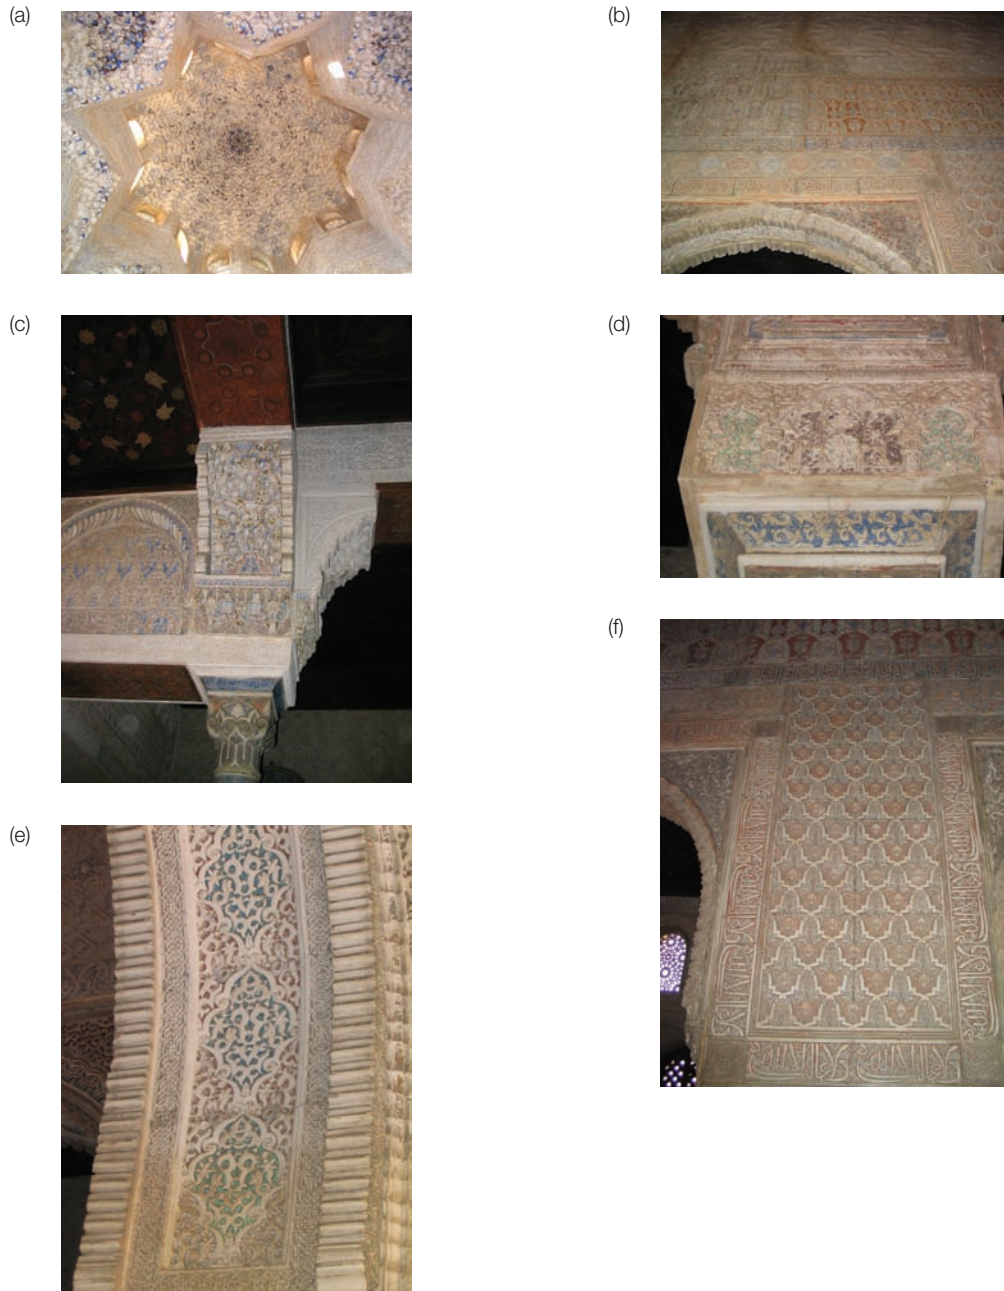
**Figure 3** The Nasrid Palaces. (a) The muqarnas cupola at The Hall of the Abencerrajes (Lions Palace). (b) The Hall of Ambassadors (Comares Palace). (c) The Hall of the Mexuar (Mexuar Palace). Detail of the colour distribution and gold decoration in the arch intrados. (d) Capital of a column at the Lions Palace. (e) Arch intrados in the Lions Palace showing different tones of green as the result of green malachite alteration forming copper chlorides. (f) Detail of unions between stucco panels in the Hall of Ambassadors (Comares Palace).

V), and remodelled or covered original, deteriorated polychromy with white paint. This paper analyses and compares both polychrome stucco considered by experts to be original Nasrid and those of uncertain chronology. It can be seen that the polychromy covering the stucco was carefully performed even in unreachable areas such as ceilings decorated with *muqarnas* – a honeycomb-like or stalactite decorative motif consisting of numerous niches – (Figure 3a). Moreover, the colour distribution is governed by a symmetrical pattern (Figure 3b) and gold decoration is restricted to the *muqarnas* (Figure 3c). Discoloration, blackening and alteration of pigments is widely found (Figures 3b, 3d and 3e). In the Alhambra, few surfaces were painted black; indeed, this colour was only used to outline the decorative motifs. In addition to this, after six centuries few remains of black are still extant (Figure 3d). Joints between panels of stucco, revealing that moulds were used, are found in diverse rooms (Figure 3f).

However, until now, compositional and textural studies had not been carried out to corroborate this supposition. It makes sense that in the late Nasrid period working methods became systematized, using casts to produce more complicated decorative motifs than before; the Kufic and cursive epigraphs with geometric and vegetal motifs are more time-consuming in their execution (Figure 3f).

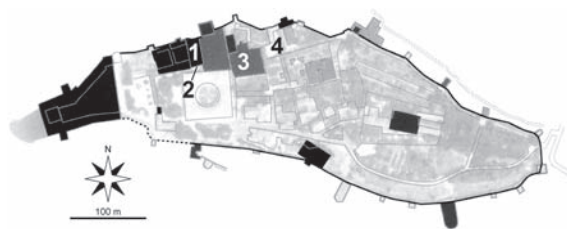
**Figure 4** Floor plan of the Alhambra and Generalife showing the sampling campaign. 1: Hall of the Mexuar (Mexuar Palace); 2: gate of the Mexuar (Mexuar Palace); 3: Lions Courtyard (Lions Palace) and 4: Muslim House (González-Pareja House) of the Partal Palace.

Twenty-four samples (Table 1) were taken from the following areas in the Alhambra (Figure 4): three from the east wall of the Hall of the Mexuar (conference room for the Arab rulers) (Mx), three from the façade of the gate of the Mexuar (GMx), ten from the interior wall of the east pavilion in the Lions Courtyard (Lions Palace) (LC) and eight from the upper floor of the González-Pareja House which is one of the three Muslim houses of the Partal Palace (MH). The sampling procedure was guided by:

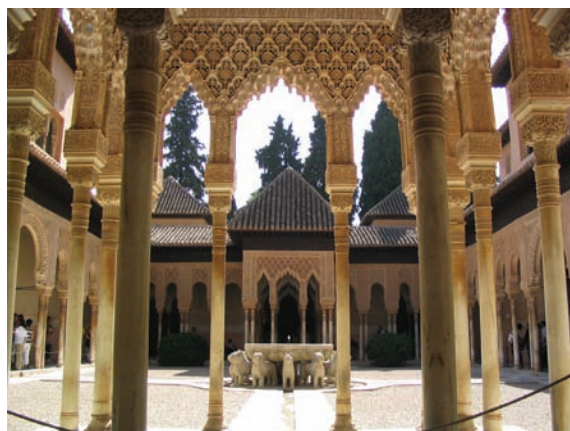
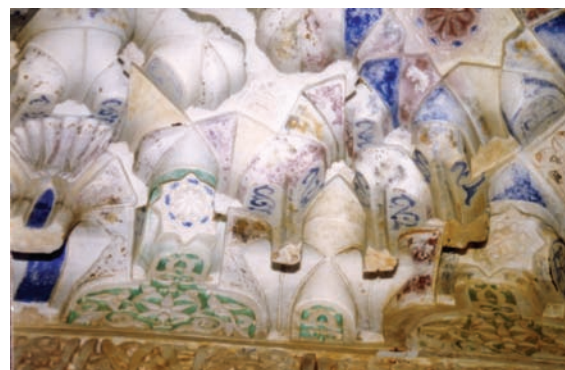
**Figure 6** (a) The Lions Courtyard (Lions Palace) and the east pavilion (sampled) seen from the west pavilion. (b) Detail of the sampled area of *muqarnas*. Note the advanced deterioration of the remaining polychromy, particularly the violet spots that appear in localized zones where gilding was identified, and the emerald colour of the original malachite green.

Two small pavilions jut onto the east and west sides of this courtyard, each housing a small fountain (Figure 6a). The courtyard has undergone numerous interventions and remodellings that have altered its original appearance, in particular the pavilions. The following colours were observed in the stucco covering the interior walls of the east pavilion: white, orange, red, different tones of green and blue, violet, metallic grey and gold (Figure 6b). In order to establish whether the tonalities are due to artistic intention or caused by alteration processes, several of these tones were analysed by SEM–EDX, including the most intense ones considered to be original, unaltered pigments. Isolated violet patches with different tints are observed in the *muqarnas* in association with sheets of tin. Samples were taken from the north, east and west walls of the interior of this pavilion. The SEM microanalysis of the *scagliola* shaping the stucco did not detect strontium. Examination by PLM revealed that grain sizes ( $\approx 140 \times 375\ \mu\text{m}$ ) of the impurities such as clays, iron oxides and calcium carbonate were larger than in the rest of the *scagliola* studied.
