Microalgae associated with deteriorated stonework of the fountain of Bibatauín in Granada, Spain

The fountain of Bibatauín, in Granada (Spain), is in a poor state of conservation, and biodeterioration is occurring. Colonization by microalgae and its effects on the fountain were investigated. The microorganisms from representative sampling areas were identified by optical microscopy, and the biogenic carbonate crusts they formed analysed by X-ray diffraction and field emission scanning electronic microscopy. The most representative genera found were *Cosmarium*, *Phormidium* and *Symploca*, and the main mineral was calcite.

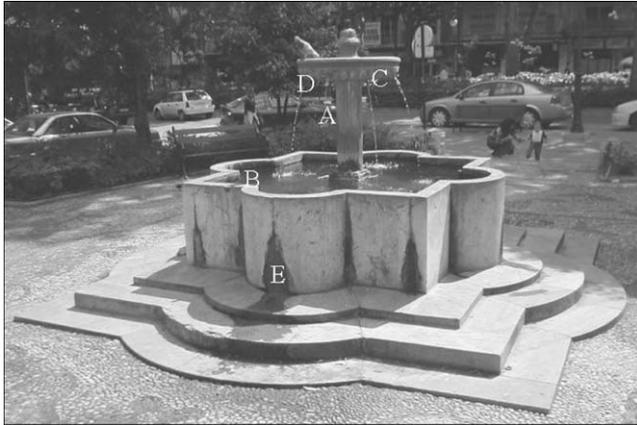
Fig. 1. General view of the fountain of Bibatauín and sampling areas A–E (see text for explanation).

An initial survey of the fountain revealed five main areas of concern (Fig. 1, A–E). Algal growth and other indicators of biodeterioration phenomena were evident. Each biotype and genus identified among the algae detected in the samples from each of the selected areas of the monument is reported in Table 1.

Area A (Fig. 1), the vertical exposed surface around the base of the pillar, was covered by a thick biofilm, and brown pustules were also found. This vertical surface was not submerged, but often wet owing to splashing and variations in water level. No mineral crusts were found, but the type of biofilm described is a preliminary step in their formation. The genera identified (Table 1) are mainly of algae ensheathed in gelatinous products, the presence of which is related to mineral fixation.

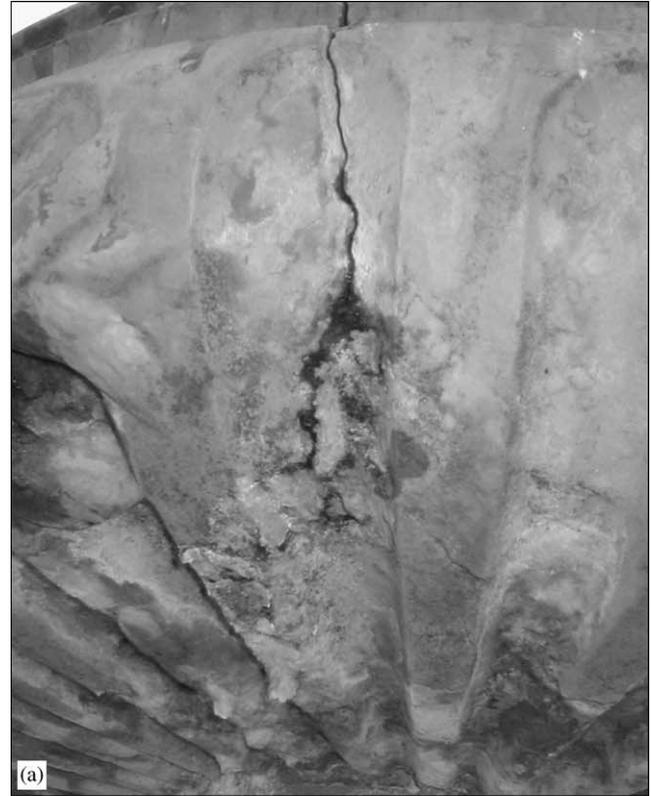
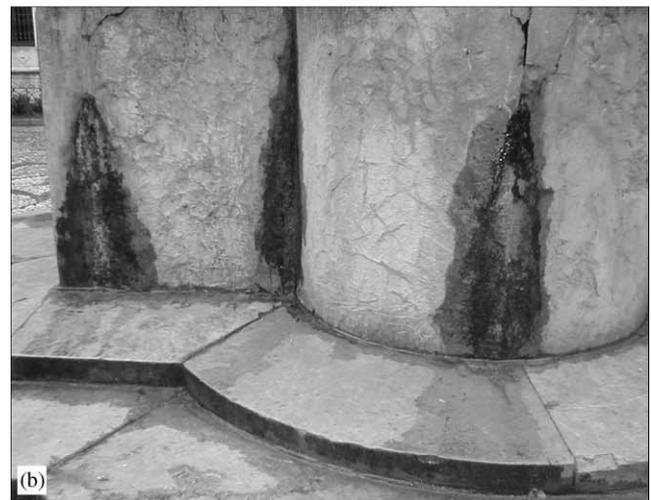
Fig. 2. Effects of biodeterioration: (a) biogenic carbonate crusts and (b) biological patinas on different surfaces of the fountain.

Several genera of filamentous cyanobacteria with sheaths were identified in areas C and D. Both were wet exposed surfaces, the former under the upper basin and the latter by the jets in this basin. Area C was characterized by thick mineral concretions, cracks in the stone and dried-out algae (Fig. 2a), and area D by thin mineral concretions, patches and pustules. *Phormidium*

(Fig. 4) was present in C and *Symploca* in both areas. Water from the upper basin continually ran down over those areas, contributing to the formation of mineral stalactites, and cracking of the stone. Microalgae beside the cracks and mineral structures contributed to crust formation (Fig. 2a).
