# Evaluation of the effectiveness of treatment products in improving the quality of ceramics used in new and historical buildings

# Giuseppe Cultrone<sup>a,\*</sup>, Fatma Madkour<sup>b</sup>

Ceramic samples made with a mixture of 70% ball clay and 30% guartz sand were moulded and then fired at 900 °C in an electric kiln. Samples were then treated with different products and analyses and tests were performed to evaluate the physical changes induced by the application of these products and their effects on the quality of the ceramics. A petrographic study indicated that the ceramics were composed of quartz, small amounts of mullite and sanidine and traces of hematite. Mineral clays (i.e. kaolinite) disappeared during firing. Two consolidating products (Paraloid B72 and Tegovakon V) and one water repellent (Silo 111) were applied to samples by capillarity, and physical changes (colour, water flow, porosity and pore size distribution) were measured. Finally, we carried out salt crystallization tests in order to determine which product improved the quality of the ceramics. Treated samples registered a decrease in porosity and a general increase in pore size. The application of Silo 1

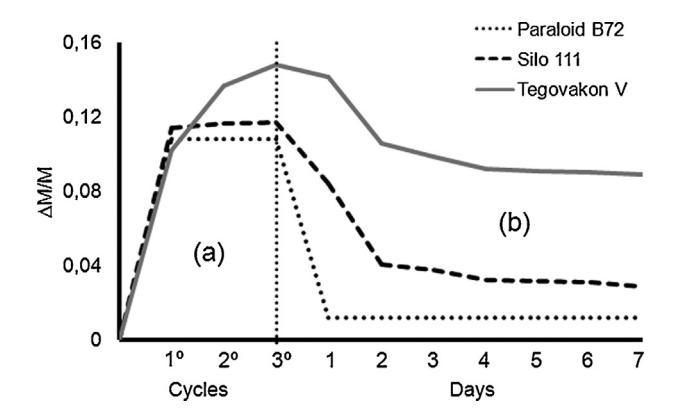
**Fig. 1.** Weight variation  $(\Delta M/M)$  of ceramic samples during treatment application by immersion for three cycles of 2 hours each with a gap between each cycle of about half hour (a) and during polymerization (b).

Samples were dried for 24 h at  $100 \pm 5$  °C, and then left at room temperature (20 °C) for half an hour, before the products were applied. The solution was absorbed into the samples by capillarity (only the base of the samples was in contact with the solution) for three continuous cycles of 2 hours each with a gap between each cycle of about half an hour. When the products are used "in situ" in the conservation of historical buildings, they, clearly, cannot be absorbed by capillarity and are normally applied by brush or spray gun. Despite this, in our laboratory experiments, we decided

to use capillary absorption because it ensures a more uniform distribution and a better absorption of the products in the ceramics [25]. This means that the results will not be influenced by different amounts of product being applied to one sample or another, or on one face or another in the same sample. The samples were weighed every day to monitor the polymerization process and to ensure that it was fully completed. After the first (Paraloid B72) and the second day of polymerization (Tegovakon V and Silo 111) at laboratory temperature ( $20 \pm 5$  °C), the samples almost reached their final weight (part b of Fig. 1). Those treated with Tegovakon V showed the highest weight increase after the evaporation of solvent (8.91%). Evaporation was continuous but not linear and this produced some flexures in the curves (after the first, the second and the fourth days). This may depend on the modification of the pore network during the polymerization of the products and the simultaneous evaporation of the solvents [26]. Ceramics treated with Paraloid B72, which absorbed a similar amount of product as those treated with Silo 111 (part a of Fig. 1), showed a higher evaporation of solvent. The weight increase of Silo 111 and Paraloid B72 was respectively 2.89% and 1.18%.

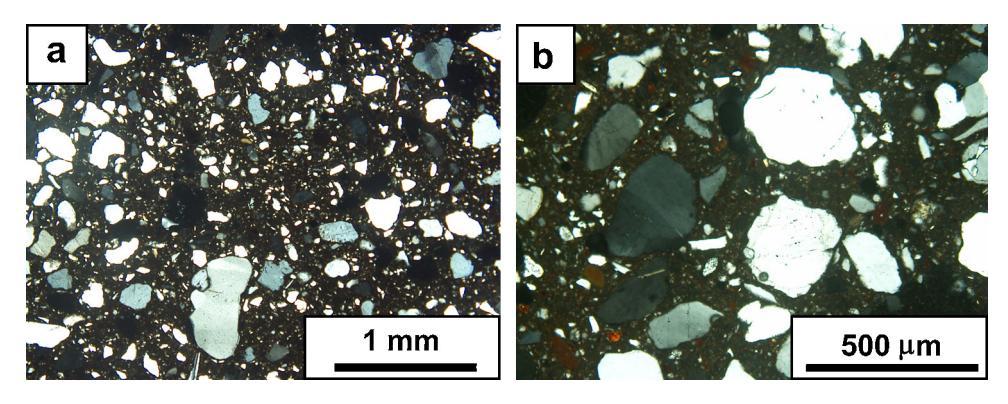
Fig. 2. Photomicrograph of fired ceramic sample showing the heterogeneity of quartz grain sizes and rounded pores distributed inside the matrix (a); detailed image showing small Fe-oxide grains (probably hematite) dispersed inside the matrix (b).

As regards the texture, the temper is composed of quartz grains with rounded to sub-rounded morphology, wavy extinction and variable size ranging up to 1 mm (Fig. 2a). A few Fe oxides/hydroxides were observed dispersed in the dark-brownish matrix (Fig. 2b). These were probably hematite, as XRD results suggest. Small phyllosilicate pseudomorphs were also observed. Their laminar habit is maintained but birefringence values are low. They may have been transformed into mullite [5] as indicated by XRD analysis. Pores were rounded and elongated in shape and homogeneously distributed in the ceramic matrix.

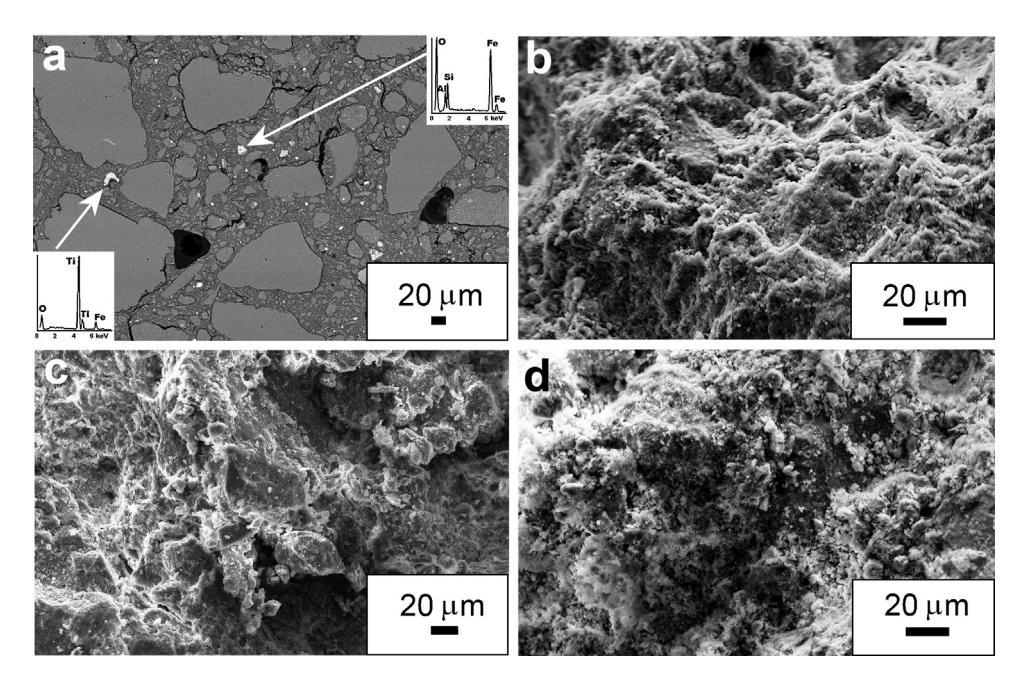
Fig. 3. a: BSE image of untreated ceramic showing the presence of oxide crystals of up to 20  $\mu$ m and larger sub-rounded quartz crystals. EDX analyses of hematite and rutile crystals are reported; SE images of samples treated with Paraloid B72 (b), Tegovakon V (c) and Silo 111 (d).

VPSEM observations showed no signs of vitrification in the texture of the ceramics (Fig. 3a). EDX analyses confirmed the presence of hematite, and also of rutile which had not been detected previously, due to its low concentrations (see EDX spectra in Fig. 3a).

The VPSEM technique was also used to observe the degree of penetration of the treatment products inside the pores of the samples. As regards Paraloid B72, it showed a weak penetration that

only favours the formation of a thin superficial layer after solvent evaporation (Fig. 3b). In fact, this was the treatment that least affected the weight of the ceramics (Fig. 1). Tegovakon V and Silo 111 products penetrated more deeply inside the samples (Fig. 3c and d).

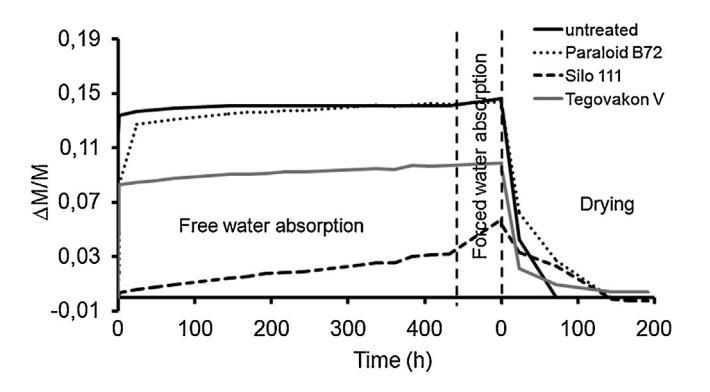
**Fig. 4.** Free water absorption, forced water absorption and drying curves for untreated samples and samples treated with Paraloid B72, Silo 111 and Tegovakon V. Weight variation ( $\Delta$ M/M) versus time (in hours).

There were significant differences between the treated and untreated specimens in terms of hydric behaviour. The samples treated with Paraloid B72 absorbed almost the same amount of water as untreated samples (~14%, Fig. 4 and Table 3), probably because of its low penetration inside the ceramic. This product is a consolidant and not a water repellent and its function is to improve the mechanical qualities. As was expected, in products treated with Silo 111, only 3% of water was absorbed (Fig. 4 and Table 3), whereas the water absorbed by samples treated with Tegovakon V was about 9.7%. When samples were submitted to forced water absorption, we observed that those treated with Silo 111 reached the highest

Ax value (45.22, Table 3). This means that the product drastically reduces the interconnection between the pores. The other products provide lower Ax values (ranging between 1.25 and 3.63, Table 3), which indicate a much better pore interconnection. The saturation coefficient (S, Table 3) is directly related to the interconnectivity of the pores and was highest in the untreated samples and decreased when the products were applied, especially with Silo 111. The untreated samples were the fastest to dry, followed by the samples treated with Tegovakon V, Paraloid B72 and, finally, Silo 111 (Di, Table 3). If we analyse the slope of drying curves in more detail, we find that all specimens are characterized by an initial "constant rate drying" [36], in which water evaporation is constant, and occurs by diffusion of vapour from the wet surface to the environment. The process is not affected by the structure of the ceramic. This first stage only occurs quickly in ceramics treated with Silo 111, while it takes longer in the other ceramics, and is slowest in untreated samples. The drying rate changes when the "critical moisture content" is reached and water loss now depends on the movement of water vapour from the pores to the surface ("falling rate drying" [36]). In this second phase, liquid movement occurs by capillarity and is influenced by the radii of the pores [37]. Notice how this second stage is similar in samples treated with Paraloid B72 and Tegovakon V. This is confirmed by their similar capillarity coefficient values (Cc, Table 3). As regards this last parameter, untreated samples absorbed water by capillarity faster than treated ones and Silo 111 stood out for its very low values, confirming its effectiveness as a water repellent.

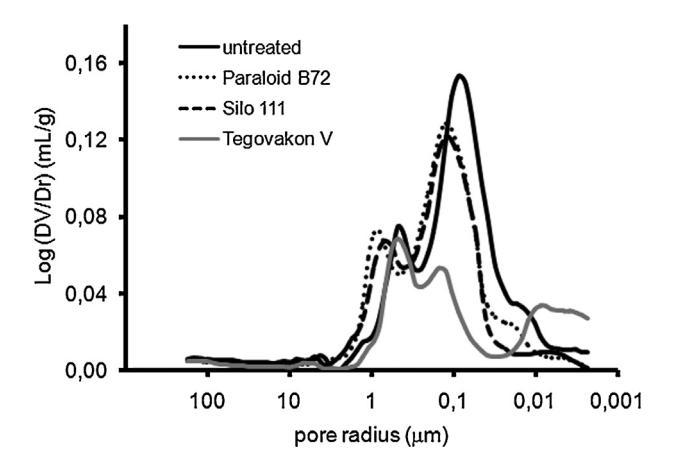
Fig. 5. Pore size distribution curves for untreated samples and samples treated with Paraloid B72, Silo 111 and Tegovakon V. Pore radius (in  $\mu$ m) versus log (DV/Dr) (in mL/g).

The MIP technique provided a reliable picture of the porosity and pore system of the ceramics and of the changes induced by the application of the different products. Untreated ceramic samples showed a bimodal curve with a main peak at around 0.08  $\mu$ m and a second smaller peak at about 0.5  $\mu$ m (Fig. 5). These pore ranges and porosity values are typical for this type of material when used in monuments and new buildings [38–40]. When samples were treated, pore radii became larger in the range between 1 and 0.1  $\mu$ m (Table 3). Tegovakon V was the only product that brought about a moderate increase in the number of pores with diameters of less than 0.01  $\mu$ m (Fig. 5) probably due to the development of microcracks in the consolidant when it polymerizes in capillaries [26].

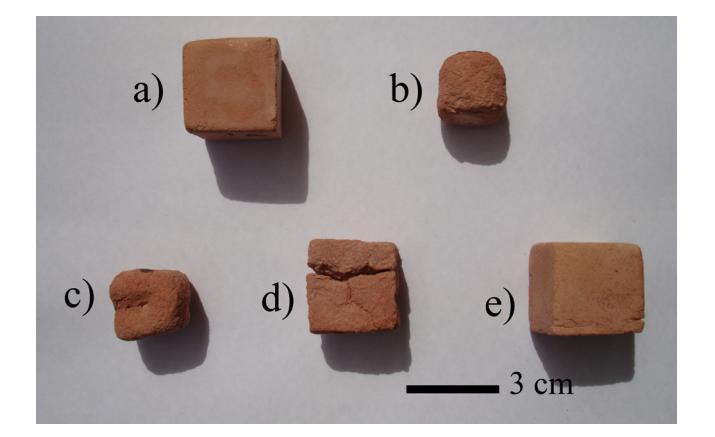
**Fig. 6.** Appearance of untested control sample and samples altered by ten cycles of the salt crystallization test: a) untested sample; b) altered sample that had not been treated with any product; c) altered sample treated with Paraloid B72; d) altered sample treated with Tegovakon V; e) altered sample treated with Silo 111.

The salt crystallization test had a considerable effect on the durability of some of the samples investigated because it led several forms of deterioration (cracking, lamination, powdering, even total disintegration) to develop (Fig. 6). Almost all samples showed a slight increase in weight after the first test cycle due to penetration of saline solution within the pores (Fig. 7). The samples treated with Paraloid B72 achieved the worst results throughout this test. In fact, after the 2nd cycle, they began to crumble. After the 5th cycle, one of the ceramics treated with this product totally disintegrated. At the end of the test, the mean weight loss was 77.86%, a value higher than that for untreated samples, which behaved in a similar way but showed a final weight loss of 69.48%.

without any alteration until the end of the test (Figs. 6 and 7). The weight loss was 0.58%. Due to its hydrorepellent properties, the application of this product hindered the absorption of saline solution into the ceramic body. In monuments in which the brick has been damaged by the presence of salts, similar efficiency has been observed in situ when water repellent products, sometimes mixed with consolidants, were applied [41].

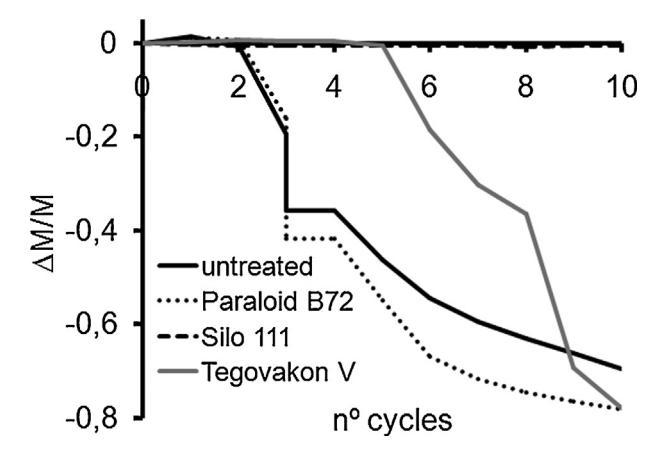
**Fig. 7.** Weight change ( $\Delta$ M/M) in untreated samples and in samples treated with Paraloid B72, Tegovakon V and Silo 111 during salt crystallization cycles.

Tegovakon V also achieved poor results, with cracks developing on the surfaces, which increased its roughness. After the 5th cycle, fragments started to fall off and one sample completely disintegrated after the 8th cycle (Fig. 7). Weight loss was again higher than with untreated samples (77.89%).
